Rejuvenation Project

Mossmorran Column Refurbishment

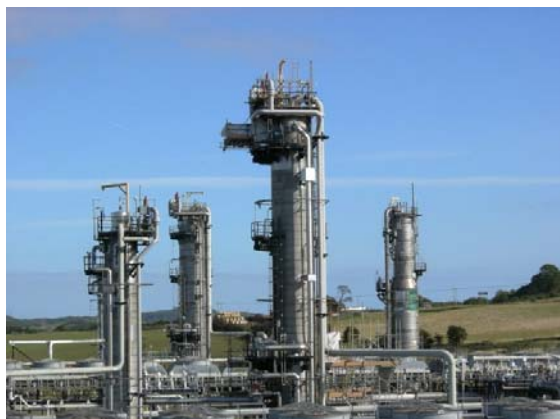
Module 2 & 3 Columns before refurbishment.

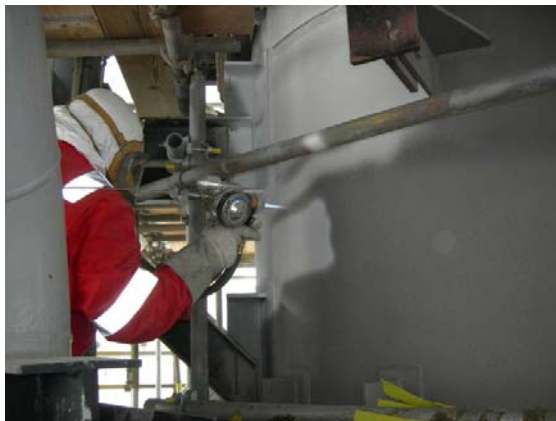
TSA being applied

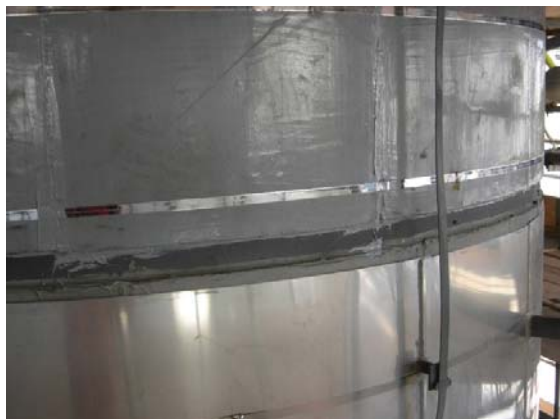
The original galvanised steel cladding had broken down allowing water into the Rockwool. In places the water was trapped and the Rockwool acted like a sponge retaining water inside the insulation and causing corrosion of the column.

Insulation being applied, showing the Terostat coated Cellular Glass above Stainless Cladding.

The Closed Cellular Glass, Terostat and Stainless Cladding provide additional barriers to prevent the ingress of water, preventing future corrosion.

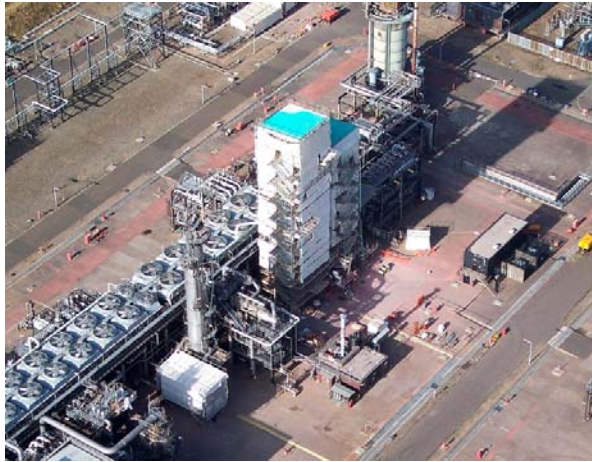
Module 1 showing 1-C1002 & 3 encapsulated.

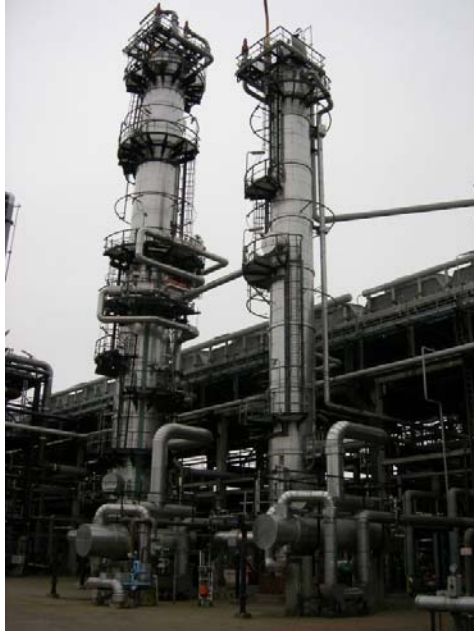
2-C1002 & 3 - Completed
